Evita 2 dura

Technical Service Bulletin # 11

Re: Product improvement for all units before S/N ARNB-0110
(Service Pack 1)

Update: May 24, 2000

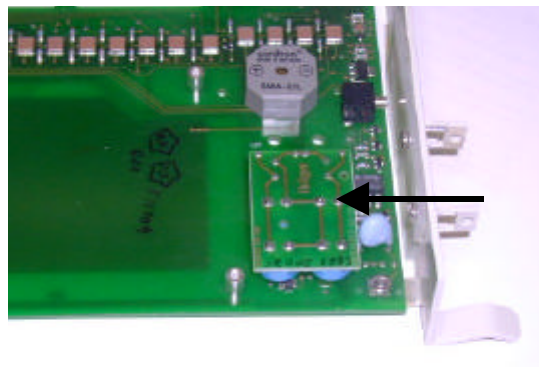
- The CO₂ Carrier PCB P/N 83 06 611 is modified with the piggy back board "SuperGold PCB". The B-side of this board is labeled with 83 09 218.
